(12) TROPICAL TESTING ESTABLISHMENT  
PORT HARGOURT, NIGERIA

## THE BEHAVIOUR OF PAINTS IN THE TROPICS

November, 1961

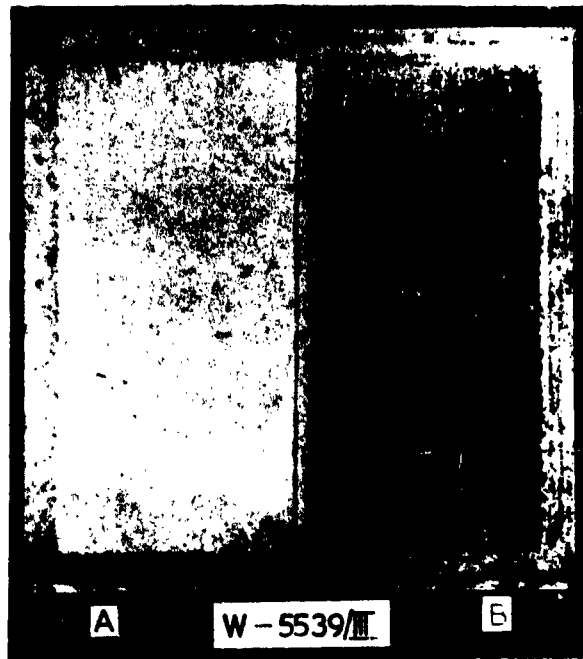
Fig.36 War Equipment Paints  
(Trial sponsored by  
M.O.S., Chemical  
Inspectorate). Arctic  
White finish after  
approximately 34 months  
exposure in jungle  
clearing. (System A4-8  
on left, A4-17 on right)  
Note very heavy rusting  
on portion without primer.

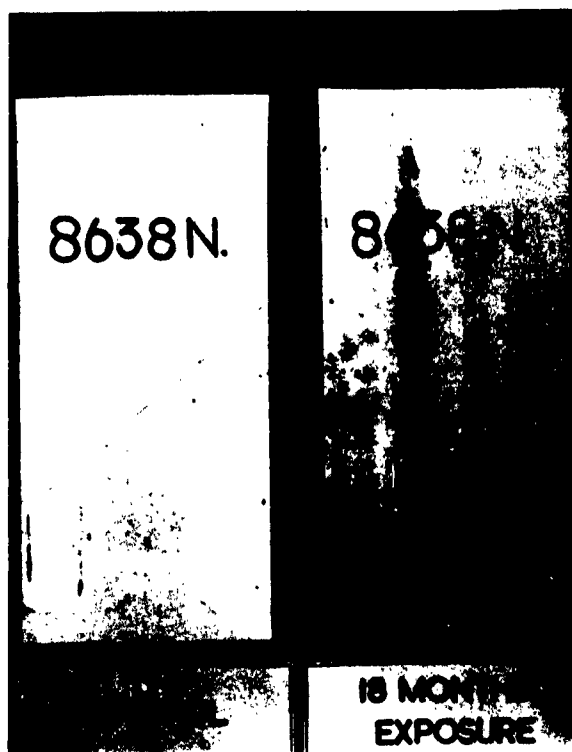
Fig.42 Paints and Varnishes (International Paints Ltd.). Specimen A8-14, after 18 months exposure at town site, Port Harcourt. Note heavy algal growth.

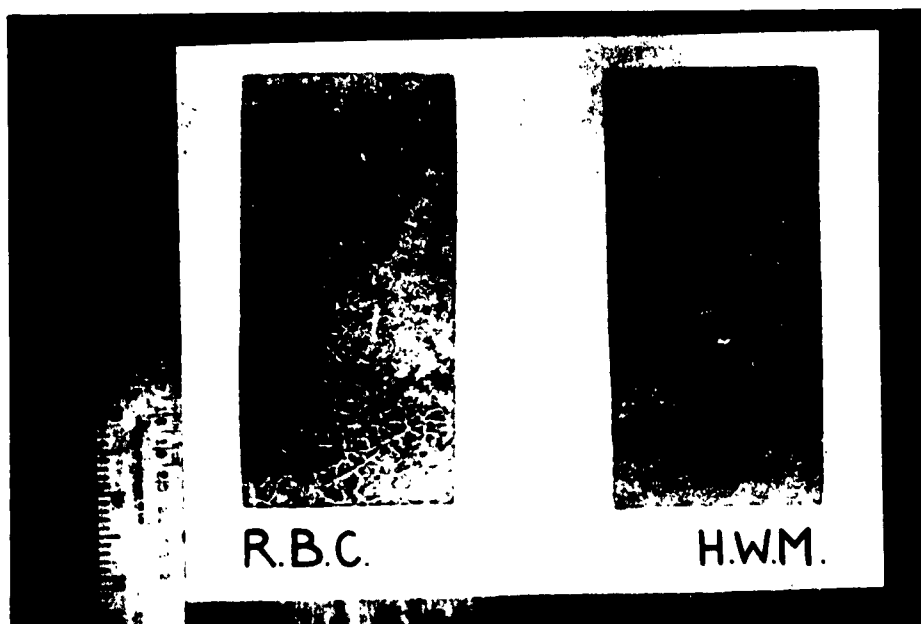
Fig.43 Chlorinated Rubber Paints (Messrs. Tretol Ltd.). Panels after 15 months exposure at the marine site showing severe checking and cracking (left hand specimen from 200 yd compound and right hand specimen from 50 yd compound).

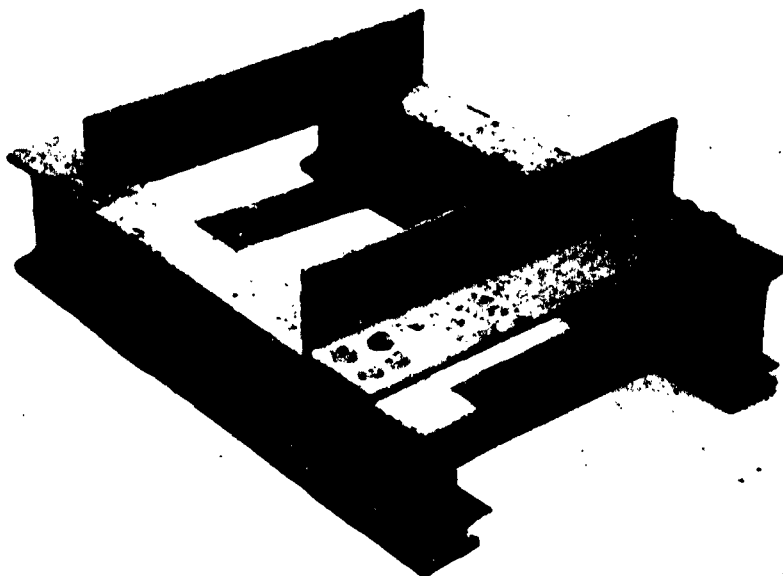
**Fig.48** Priming Schemes for Metallic Coatings (Trial sponsored by the British Iron & Steel Research Association). System A13-19 after 19 months exposure at the marine site showing severe corrosion of the metal coating and breakdown of the paint system.

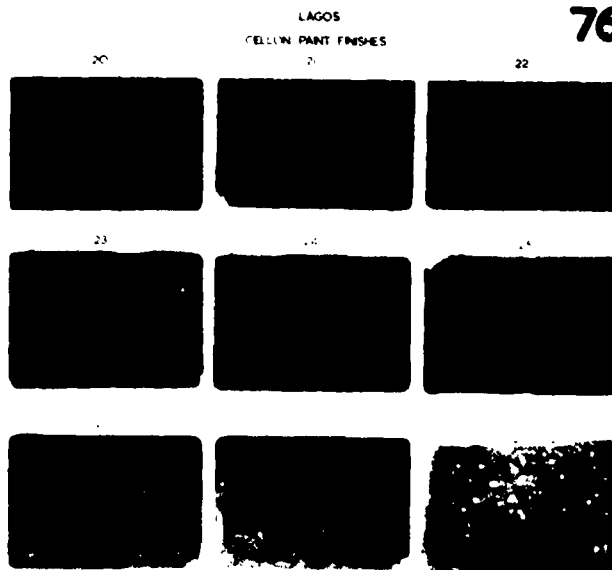
**Fig.49** Service Paint Systems (Cellon Ltd.). Specimens A16-20 to A16-27 and A16-32 after 3½ years exposure at the marine site, showing very heavy rusting of panels and almost complete destruction of the paint films.

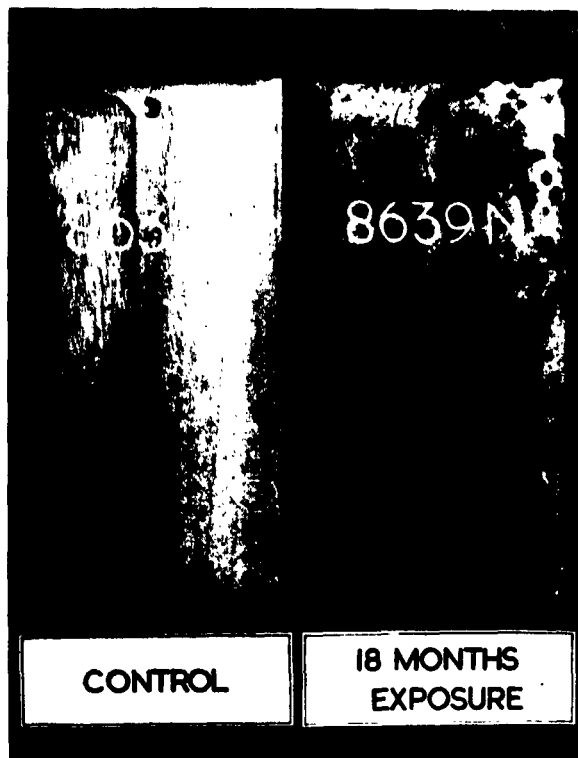
Fig.62 Commercial Varnishes  
(International Paints,  
Ltd.). E1-1 after 18  
months exposure at town  
site, showing extensive  
checking and cracking.
